## **German Commission For Paint And Bodywork Repair**

### **Fading Out Painting Process In Case Of Repair**

#### **Basics For Professional Refinishing Of Components Without Clear Separation By Dividing Elements**

Released: 2023-03-07

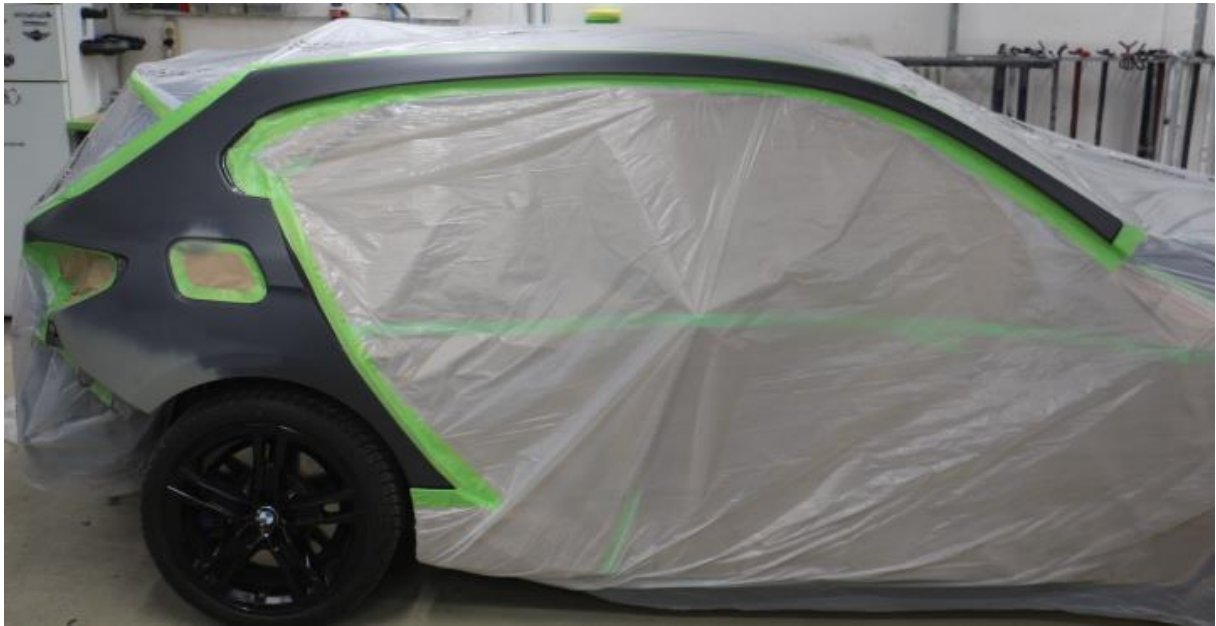
*Figure 2: Vehicle prepared for topcoat with repair painting of the rear side panel and supplementary painting of the A-pillar at the top outside to achieve a closed clearcoat.*

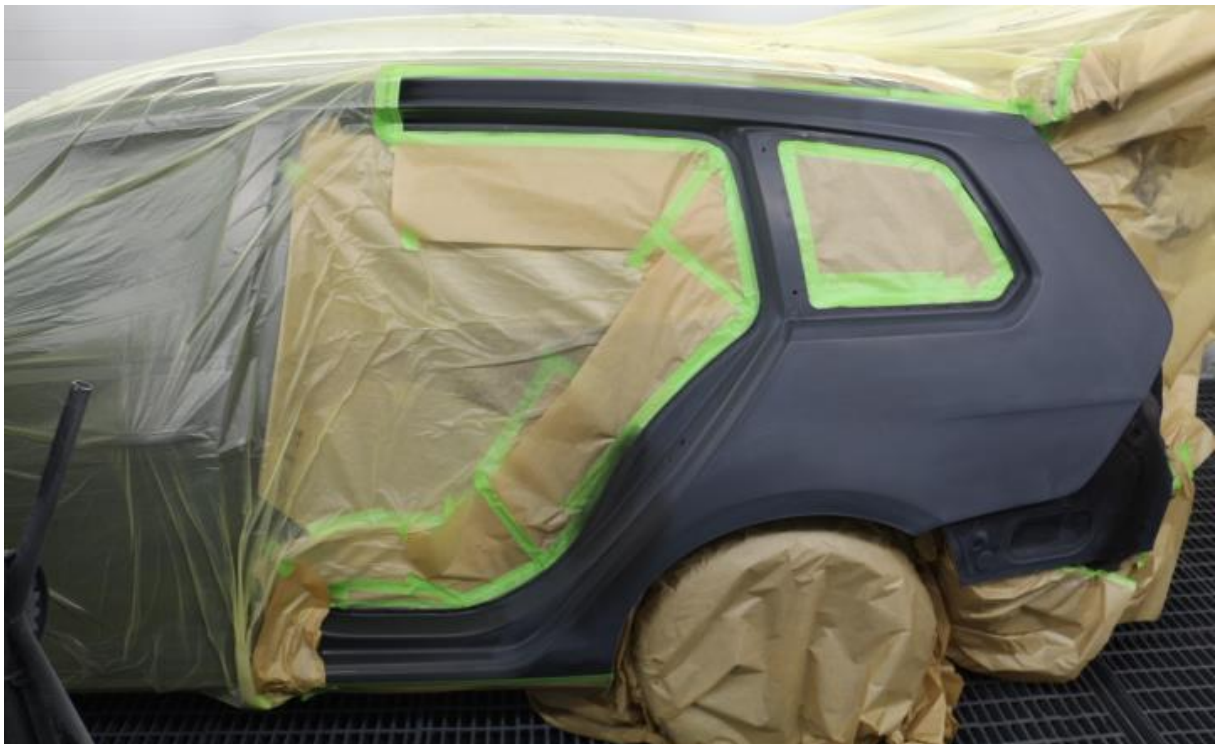
*Figure 3: Vehicle prepared for topcoat with repair paint on rear side panel and fading out painting process on roof rail and rear entrance sill area.*

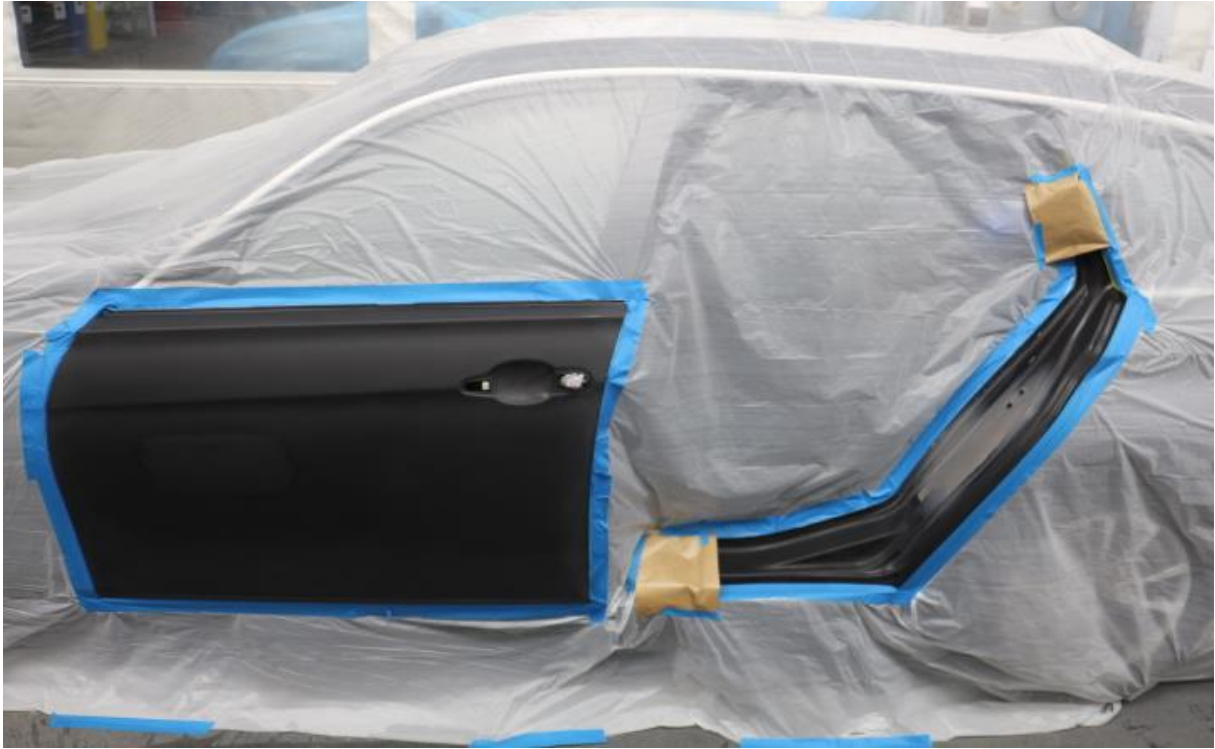
*Figure 4: Vehicle prepared for topcoat with repair painting of the rear inner sill section by the fading out painting process on the lower entry sill and along the inner C-pillar.*

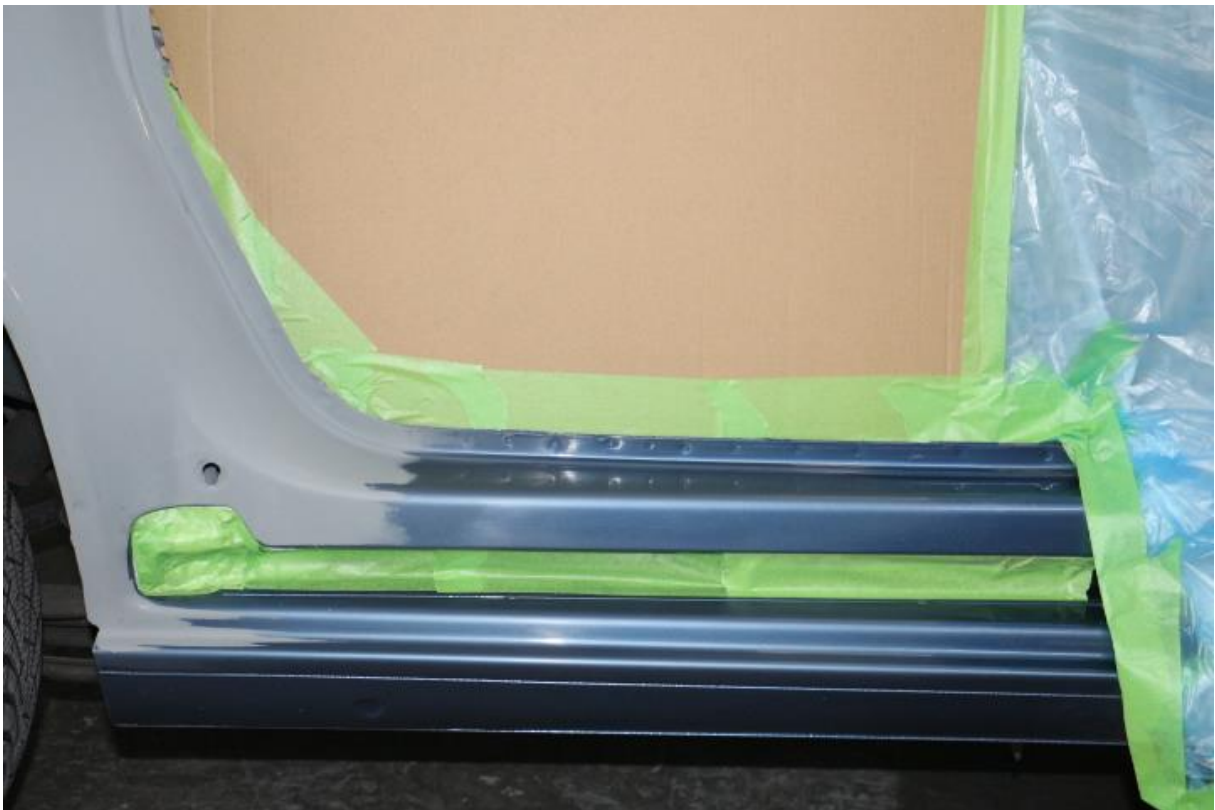
*Figure 5: Detailed view of the rear sill section prepared for topcoating using the fading out painting process.*

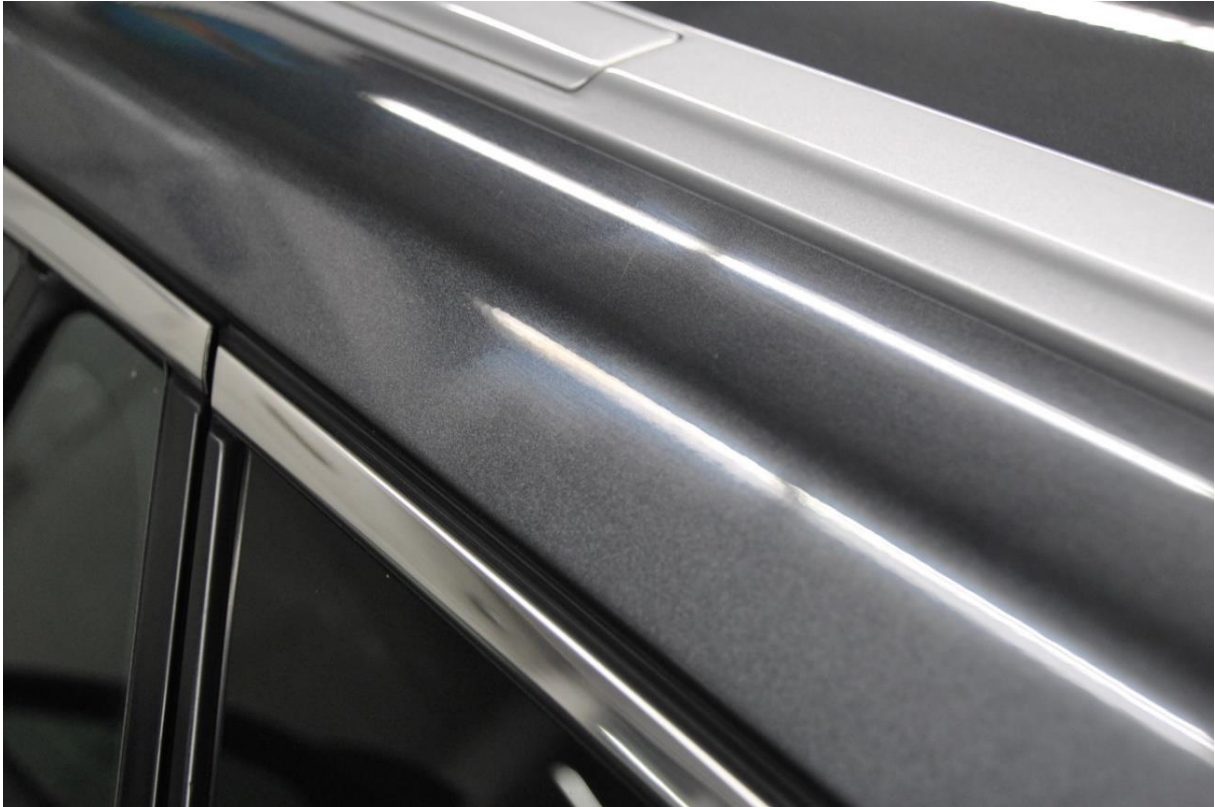
In particular, the fading out zones in the area of the side roof rail bear the risk that mechanical stresses, for example in car washes or during the use of high-pressure cleaners, as well as during vehicle preparation of the painted surfaces by means of polishing, can result in possible tear-off edges, paint peeling (delamination) or other damage patterns in the fading out zones of the clearcoat. In addition, these are in visible areas, which makes them more noticeable to untrained observers and ultimately does not represent a professional paint repair.

*Figure 6: Potential long-term consequence of a fading out painting process in the area of the roof rail - gloss level reduction / matting due to continuous weathering and aging.*

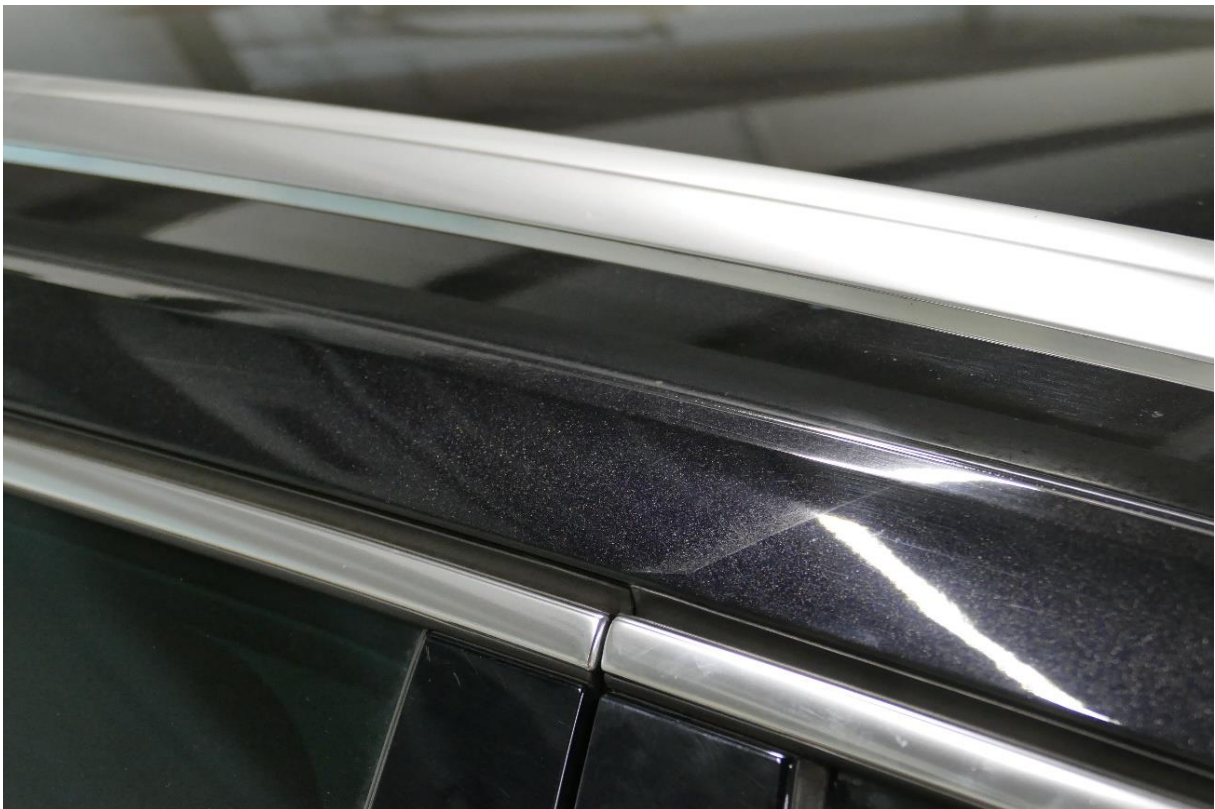
*Figure 7: Example of a sharp paint edge due to improper performance of the fading out painting process - transition area not sufficiently dimensioned and subdivided.*
